# AIRCRAFT ACCIDENT REPORT

IMPERIAL AIRLINES, INC., LOCKHEED CONSTELLATION L-049,  
N 2737A, BYRD FIELD, RICHMOND, VIRGINIA,  
NOVEMBER 8, 1961

## SYNOPSIS

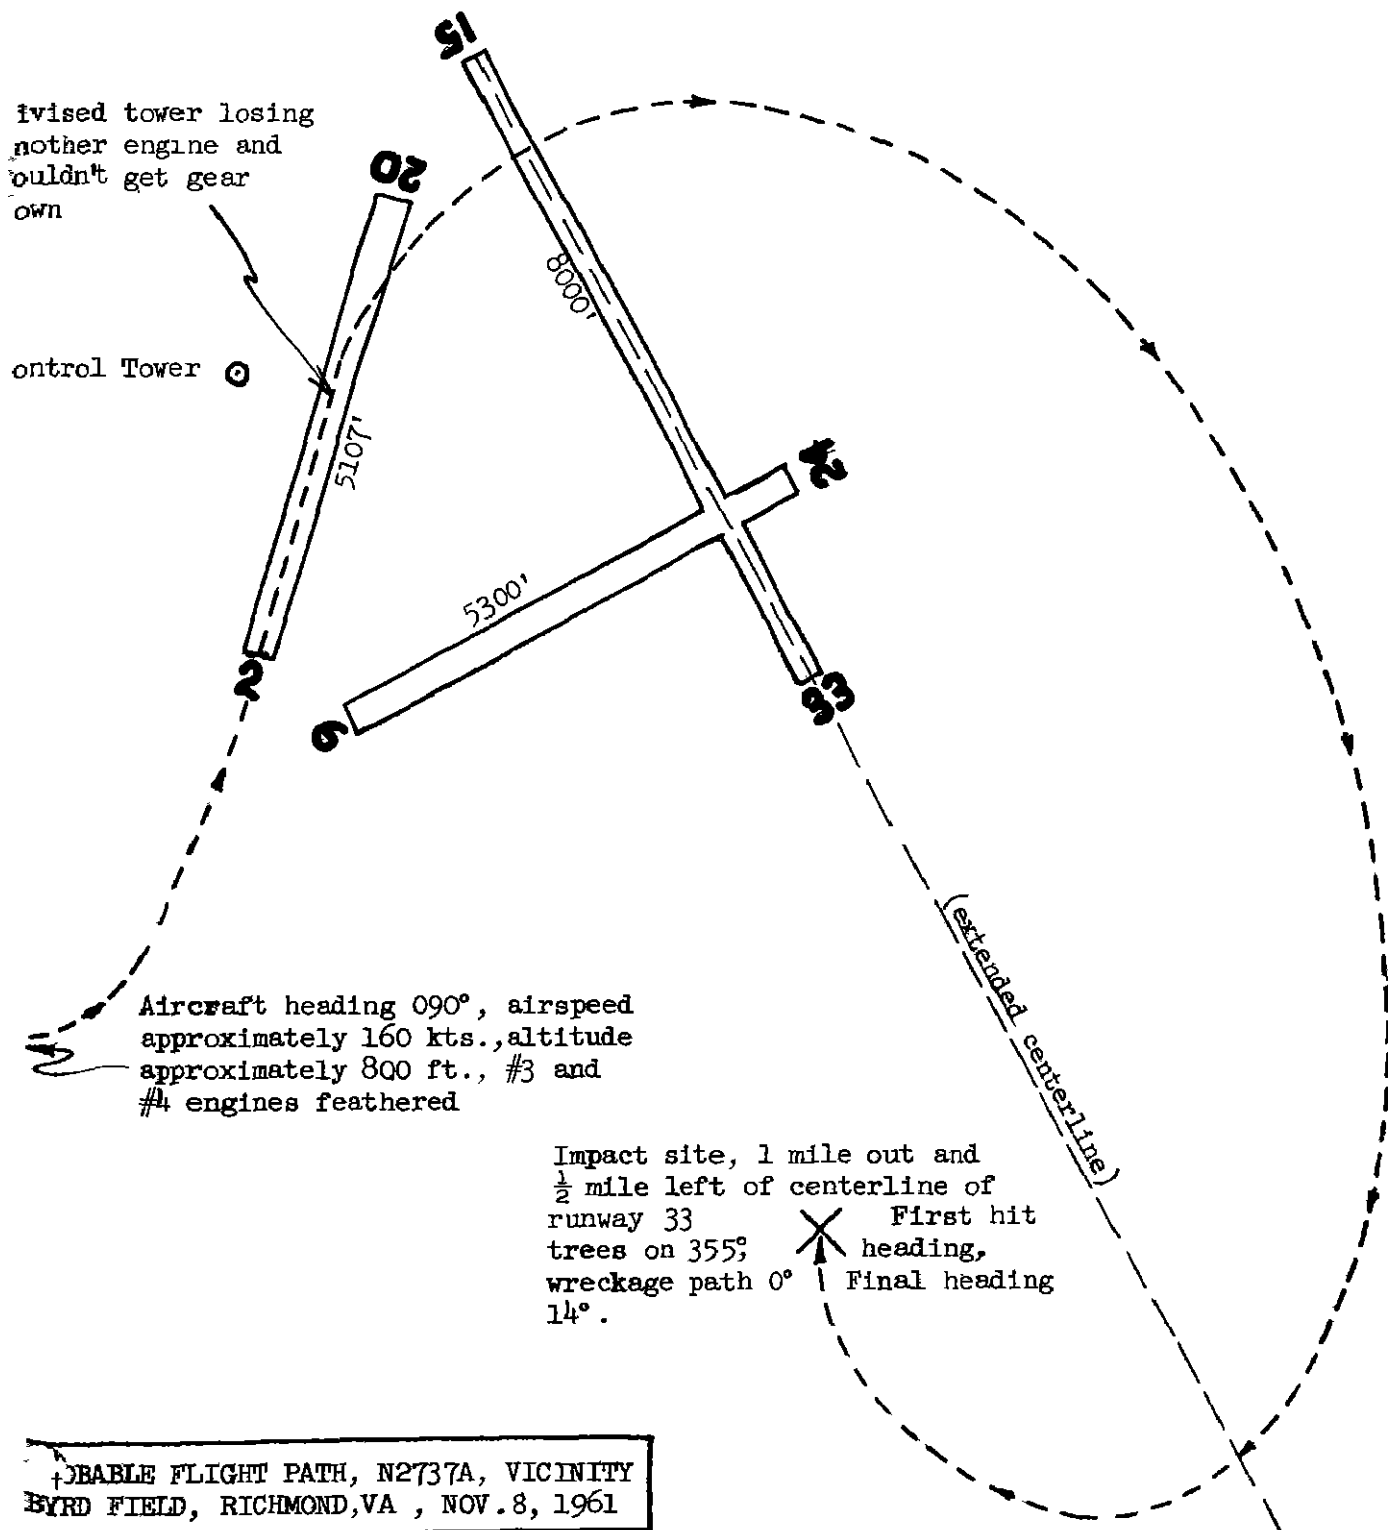
All headings magnetic

From the location of the wreckage it is apparent that the landing pattern was poorly executed. It is believed that when the airplane was on its base leg the bank angle was steepened in an attempt to avoid overshooting the extended centerline of the runway. This increased angle of bank and increased rate of turn bled off airspeed and the aircraft began to sink. To try to arrest the sink rate Greenlee called for "...all the power you got." By this time the No. 1 engine was destroying itself as a result of the over boosting during the emergency. It failed completely. With only one engine delivering power it was impossible to maintain flight and the aircraft stalled into the trees.
